Geotechnical Engineering Services

University of Washington
ASUW Shell House
Seattle, Washington

File No. 0183-139-00

August 5, 2024

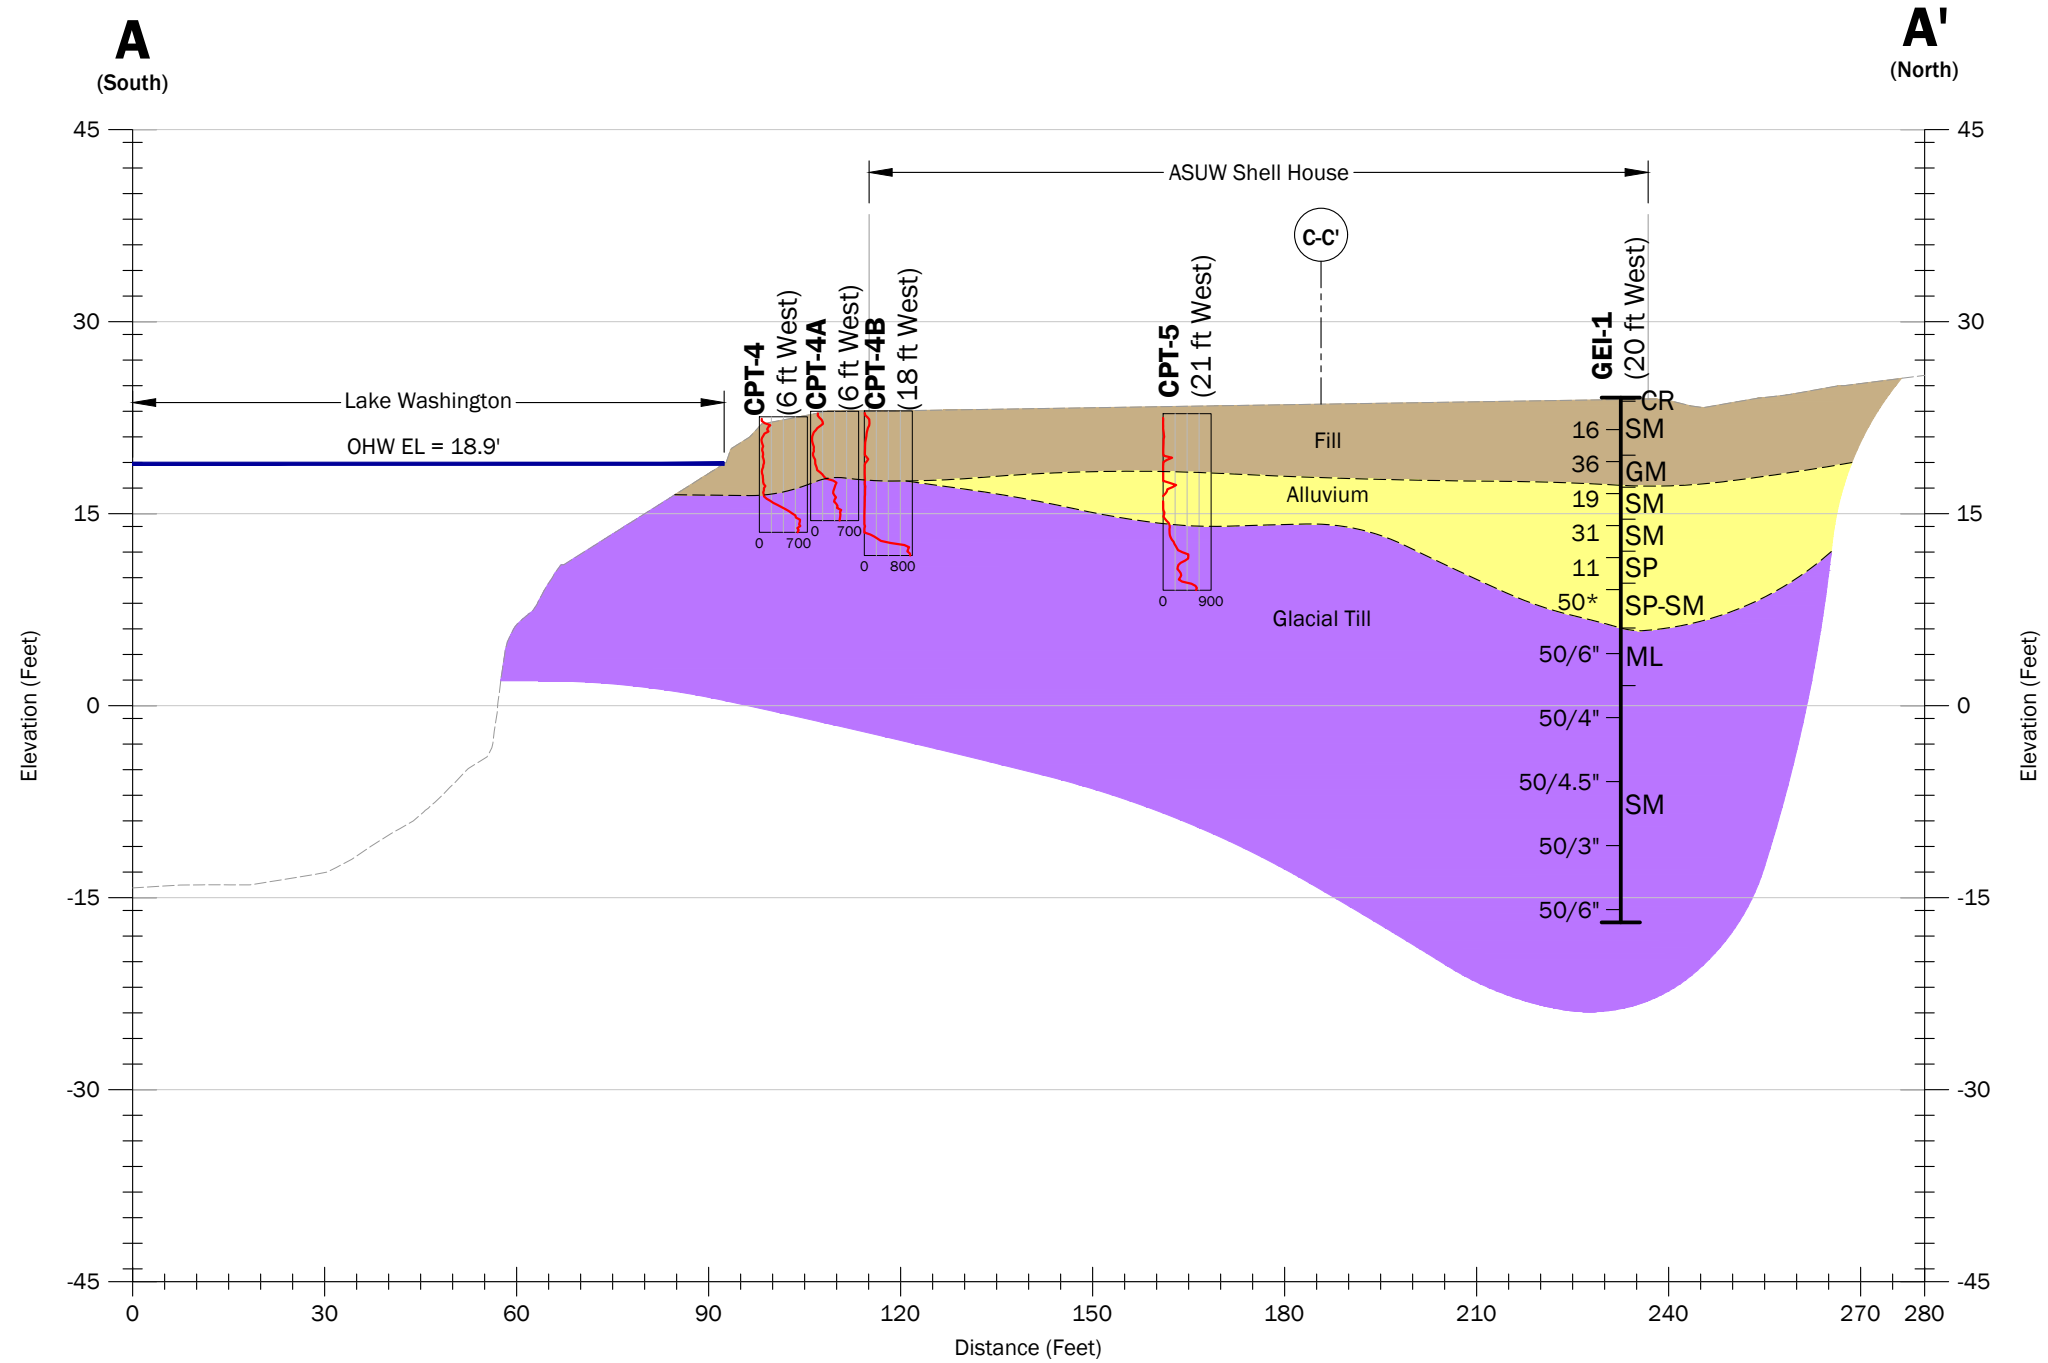
Cross Section A - A'	
ASUW Shell House Seattle, Washington	
	Figure 4

Our understanding of subsurface soil conditions is based on the results of our recently completed explorations and on our review of existing geotechnical information from previous studies in the vicinity of the site. Our interpretation of the subsurface conditions is presented in Figures 4 through 6, Cross Sections A-A' through C-C', respectively.

In general, the soils below the site consist of shallow fill underlain by alluvium, glacial till or both, and the subsurface conditions under the Shell House vary considerably. The northeast and south/southwest sides of the building appear to be located over relatively dense and shallow glacial till, while the northwest/west and southeast areas indicate the presence of alluvial soils (with or without peat). The thickness of the alluvium varies significantly across the site, ranging from 0 to about 12½ feet. It appears that some sort of

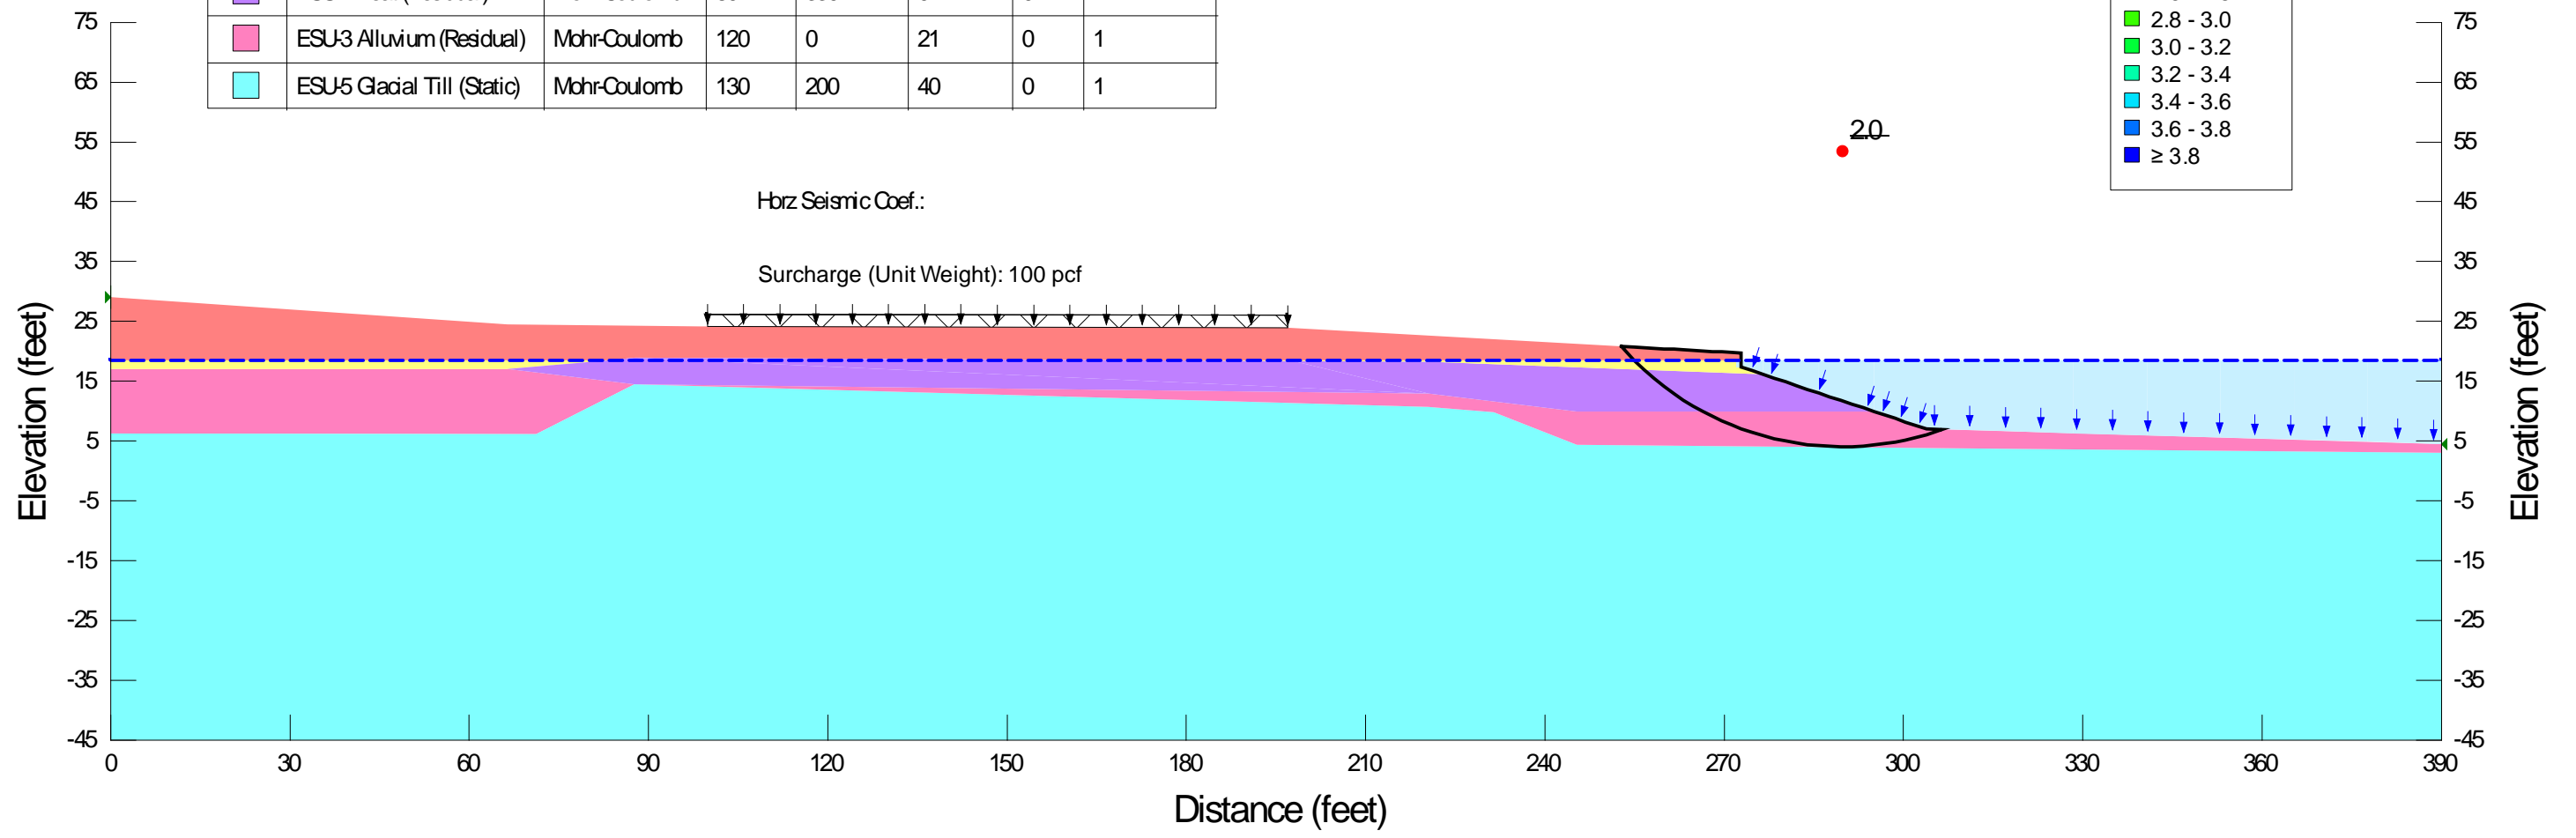
Lateral Spreading (Post-Earthquake Condition)

- Yield acceleration = 0.19g
- Lateral ground deformation ~ 11.8 inches

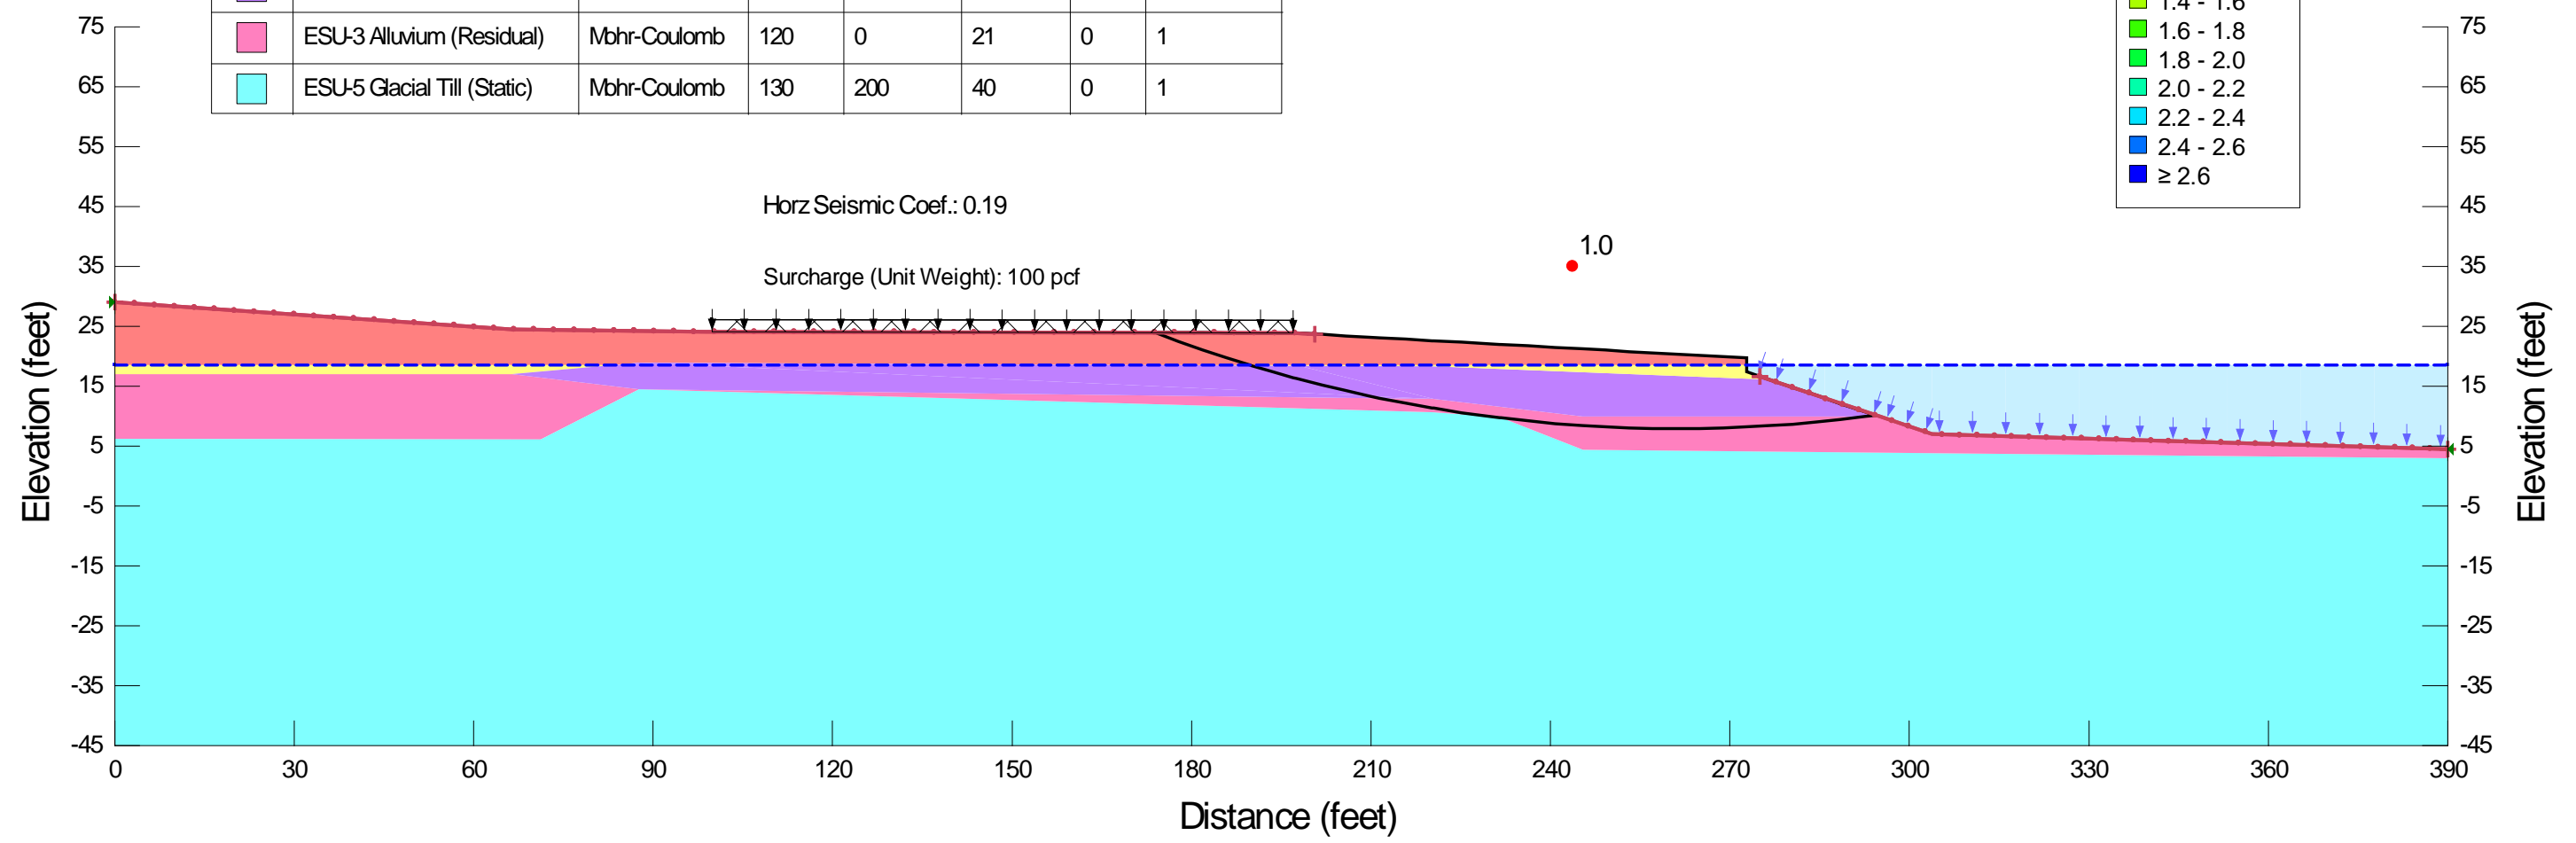
Lateral Spreading (Pseudo-Static Condition)
Peat Extends Below Building

- Yield acceleration = 0.19g
- Lateral ground deformation ~ 11.8 inches

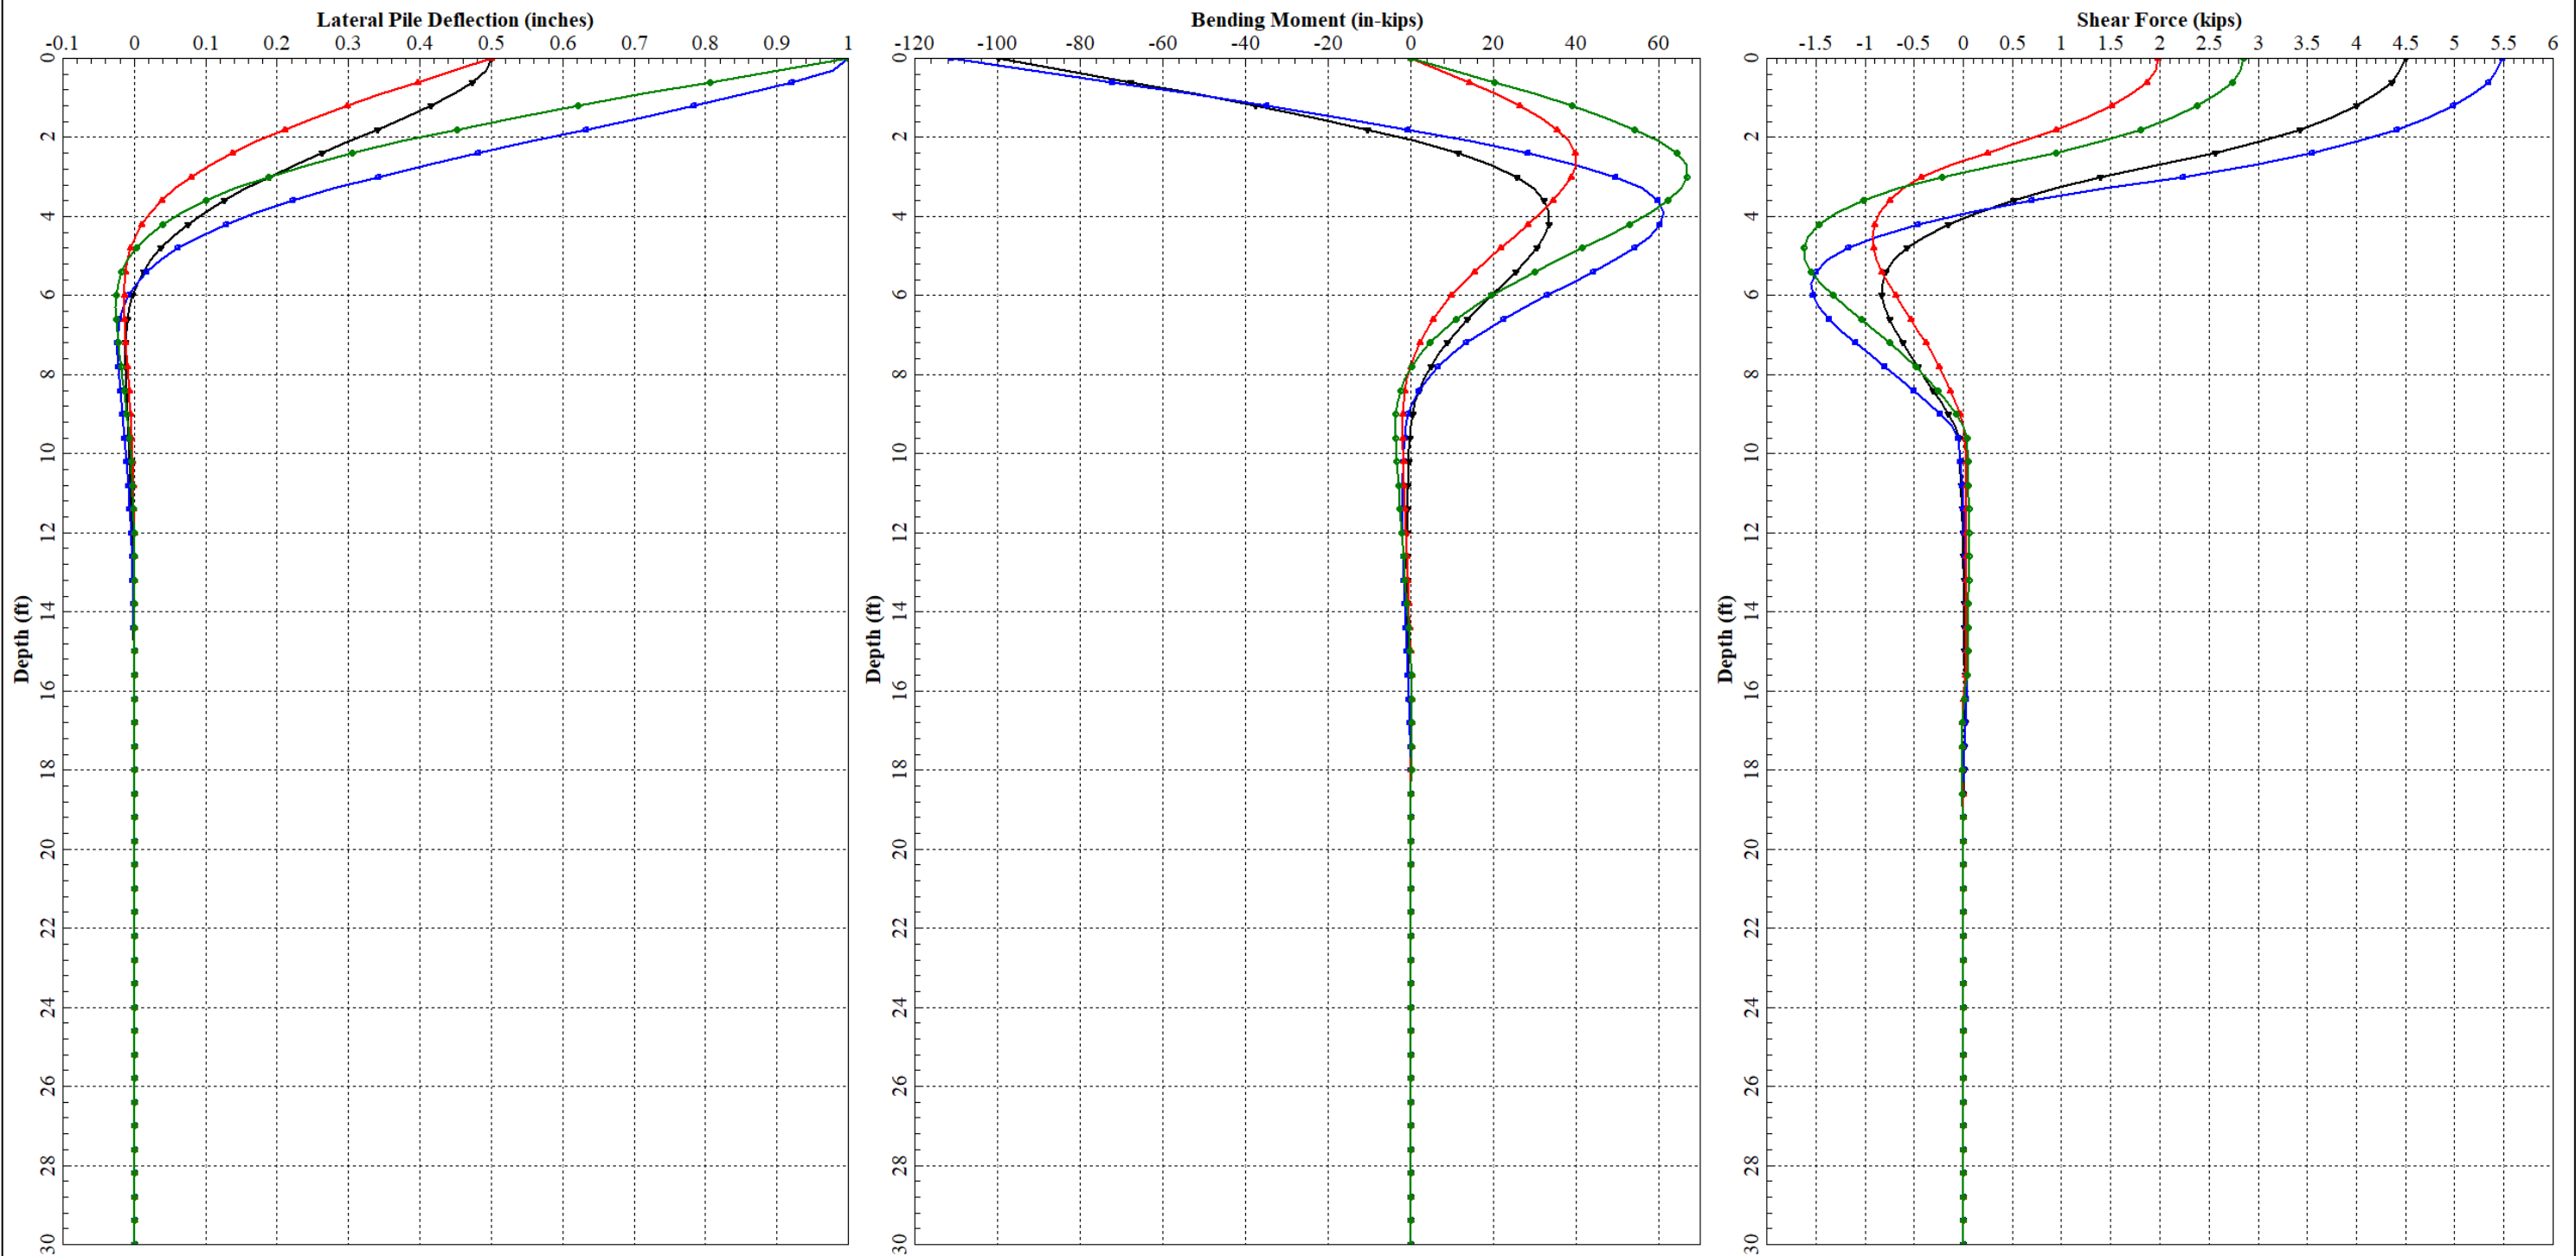
Figure 10

Pile Diameter = 6"
 Head = Both (Fixed and Free)
 Steel Reinforcing = 1 #18 bar
 P Multiplier = 0.1 (for Liquefied Soil); None (No Group Effects)

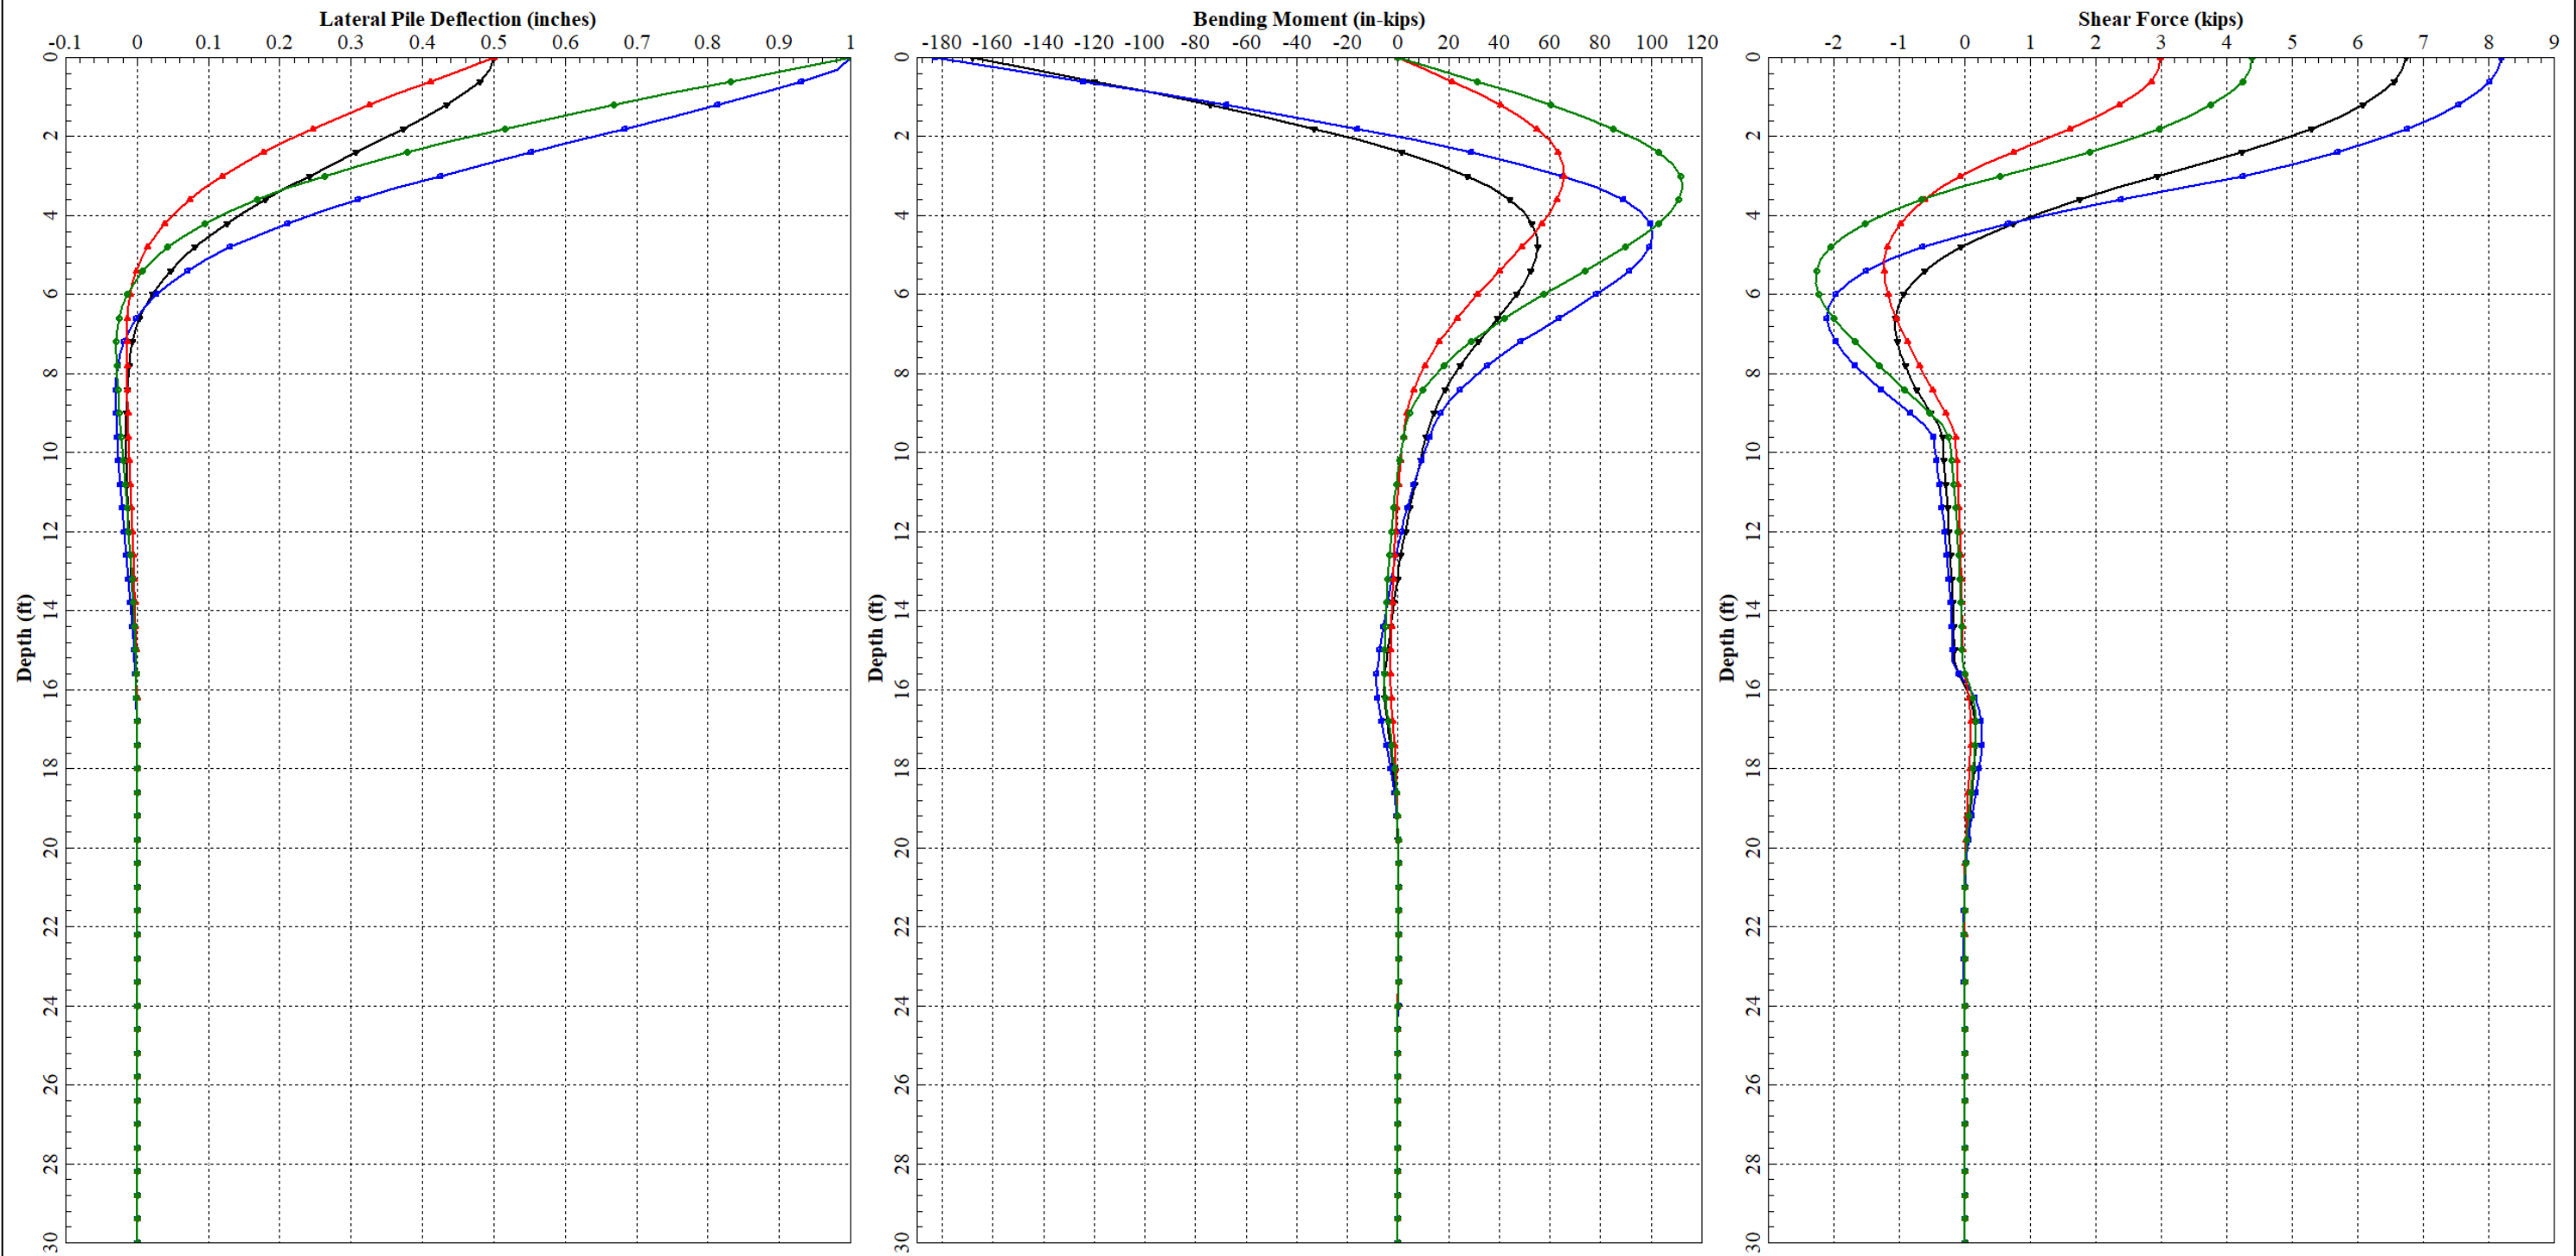
Figure 11

Pile Diameter = 8"
 Head = Both (Fixed and Free)
 Steel Reinforcing = 1 #18 bar
 P Multiplier = 0.1 (for Liquefied Soil); None (No Group Effects)

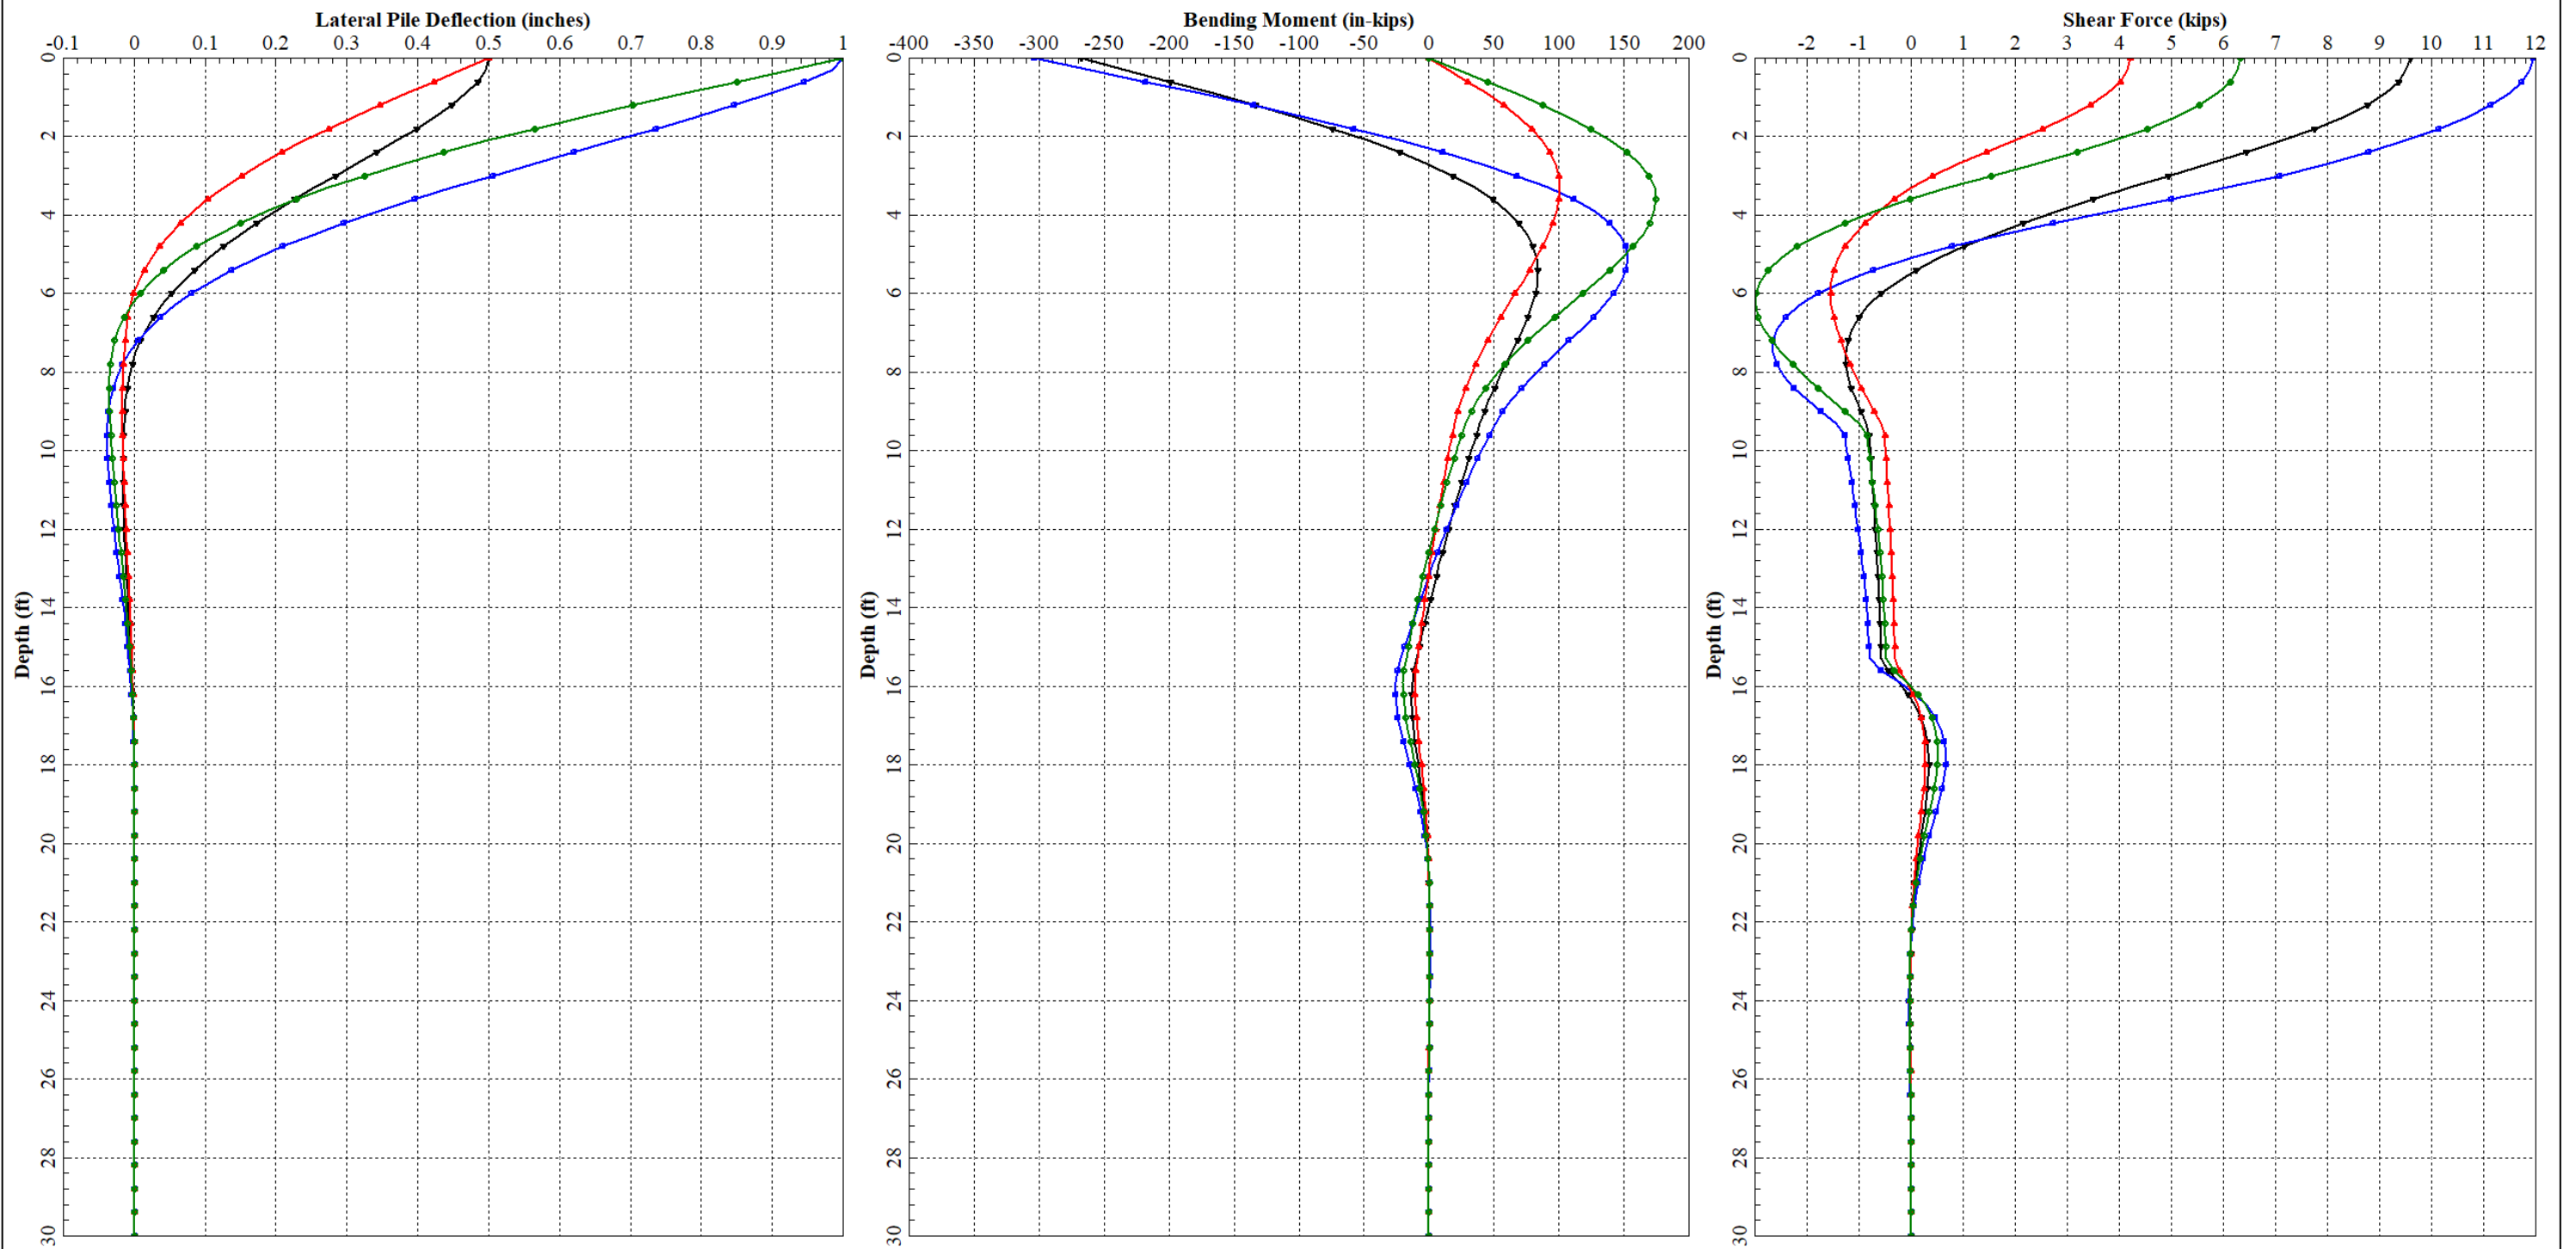
Pile Diameter = 10"
 Head = Both (Fixed and Free)
 Steel Reinforcing = 1 #18 bar
 P Multiplier = 0.1 (for Liquefied Soil); None (No Group Effects)

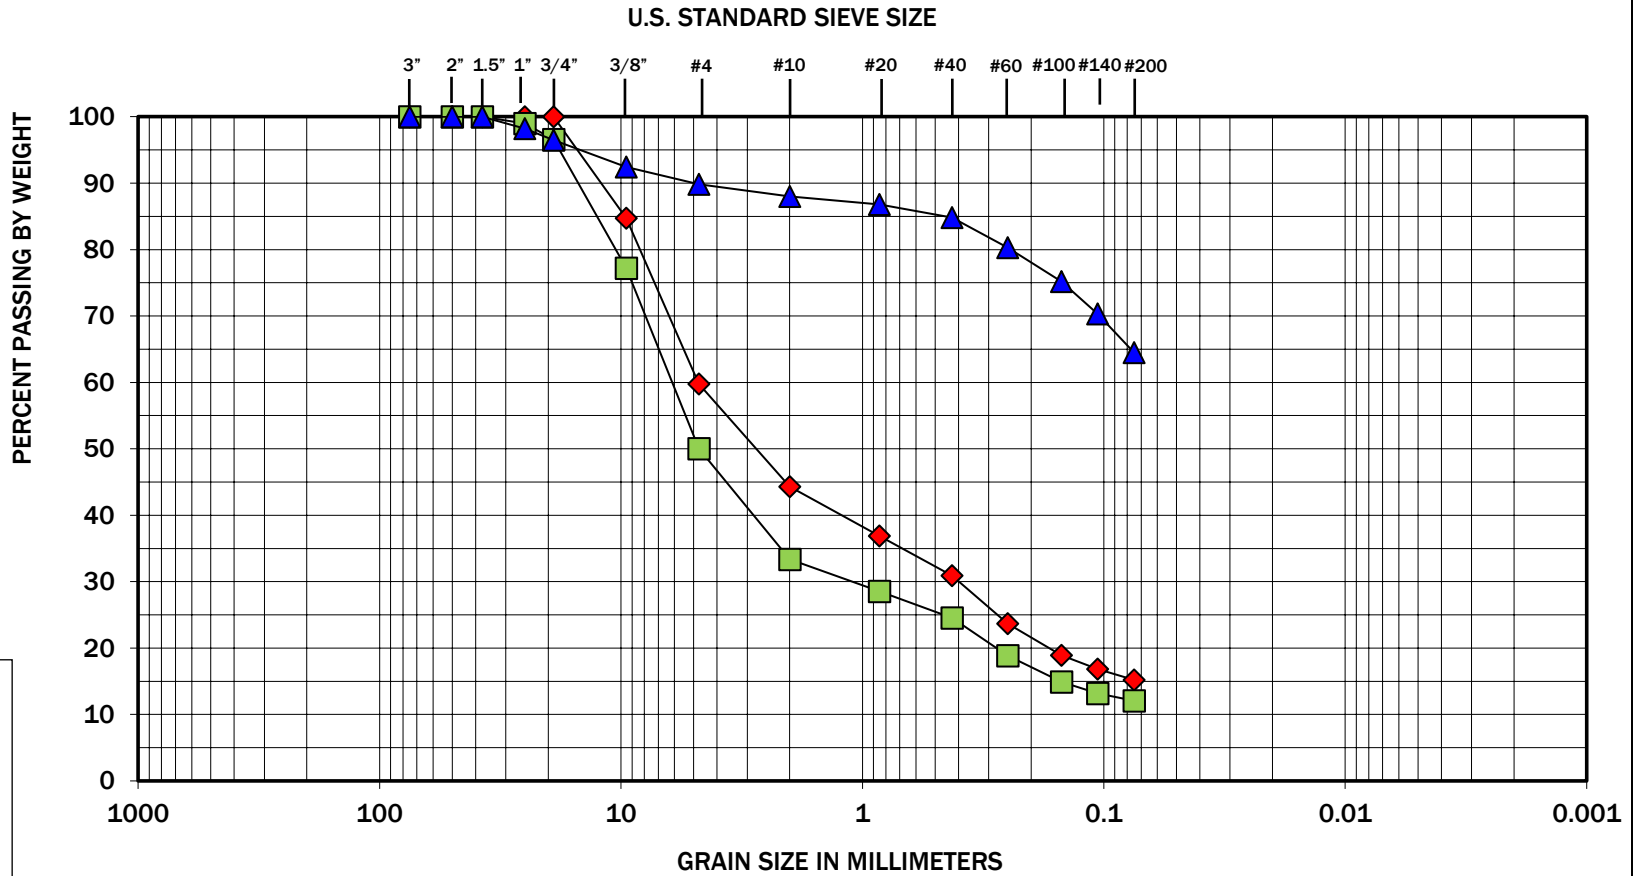
Symbol	Boring Number	Depth (feet)	Moisture (%)	Soil Description
◆	GEI-1	2.5	13	Silty fine to coarse sand with gravel (SM)
■	TP-1	4	7	Silty fine gravel with sand (GM)
▲	TP-2	2	57	Sandy silt with organic matter (ML)
