CHEMICAL SCIENCES BUILDING PROJECT

SEPA Checklist/Consistency Paper – March 4, 2026

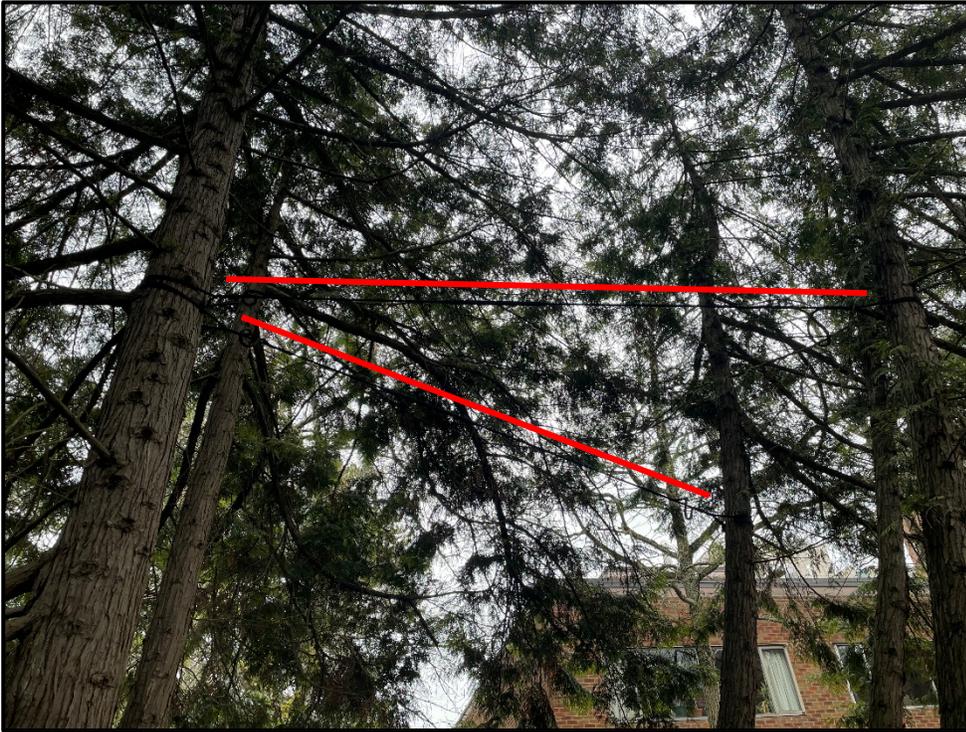
Photo 1. Tree 4729 with two taught dynamic cables which are located immediately below the red lines.

Tree 4729 has a codominant union at the base which has an active crack between the east trunk and the other two trunks. There are two taught dynamic cables supporting the east trunk which are attached to the main trunk of the tree. If this tree is retained these two dynamic cables should be replaced with steel cables.

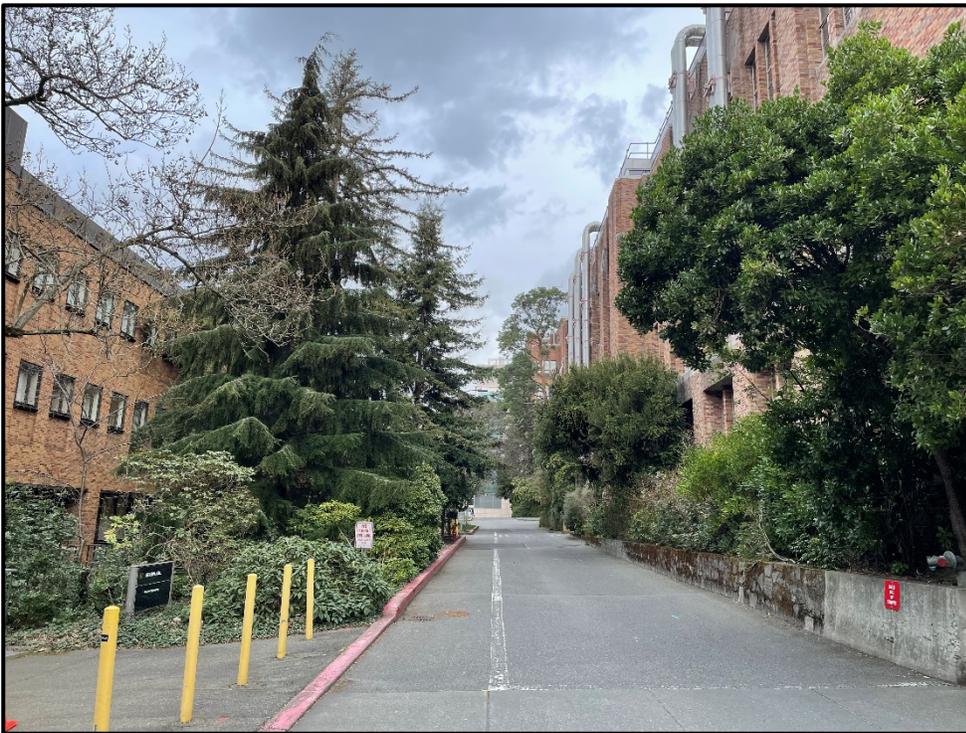
Photo 2. Photo taken looking north along Okanogan Ln NE which shows the general mature nature of the existing trees, shrubs, and landscaping.

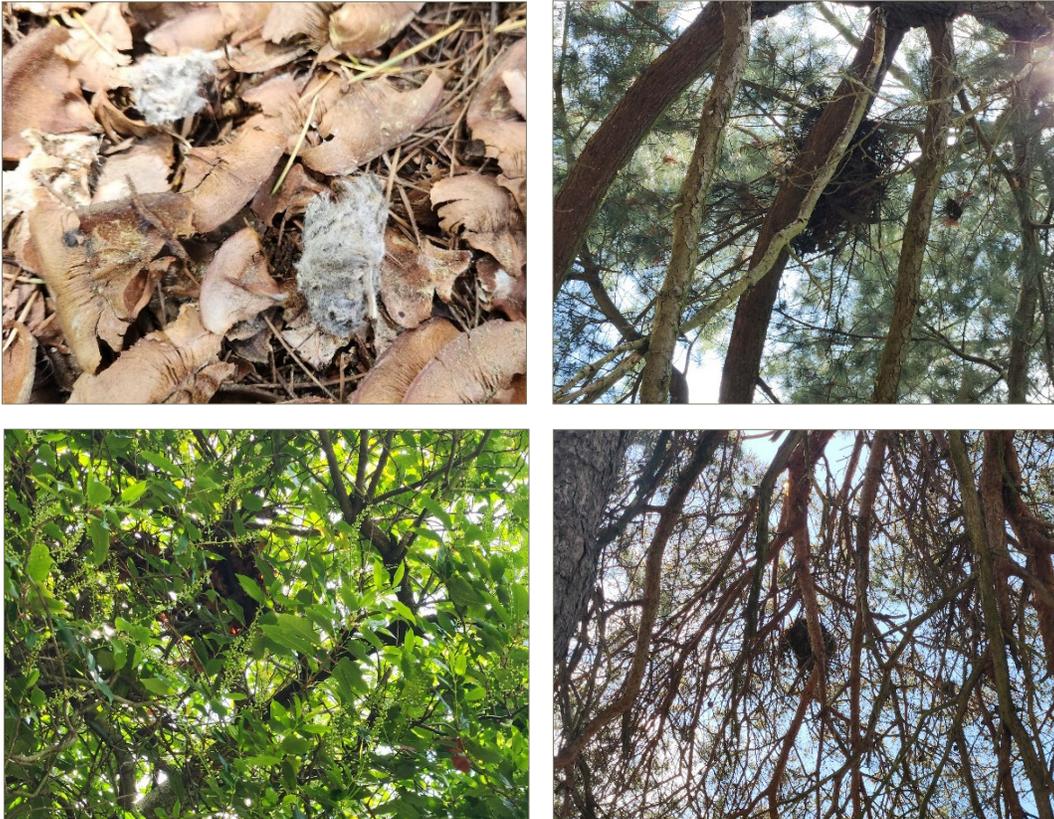
Exhibit 1: Site Observations

All photographs taken on May 14, 2025. Top left: Owl pellets under tree in southwest corner of site (Observation 1 on Figure 1). Top right: Unused stick nest (Observation 2 on Figure 1). Bottom left: Potential squirrel nest, or old unused bird nest (Observation 3 on Figure 1). Bottom right: unused stick nest (Observation 4 on Figure 1).

Within the Project footprint, owl pellets and three small nests were documented, as shown in Figure 1 and Exhibit 1. All three nests appeared inactive, showing no signs of recent construction or active nesting. The owl pellets found during the survey were not fresh and appeared to be several months old, with no evidence of active nesting within the area. The absence of fresh droppings, feathers, or prey remains, combined with the lack of adult owl activity or nestling calls, suggests the site is not currently being used for breeding. This finding aligns with documented patterns on the UW campus, where owl pellets have been discovered at locations without active nests. Since owls typically deposit pellets at roosting sites rather than nesting locations, and commonly maintain multiple daytime roosts throughout their territory, the presence of aged pellets likely indicates historical use of the area as a temporary resting site.

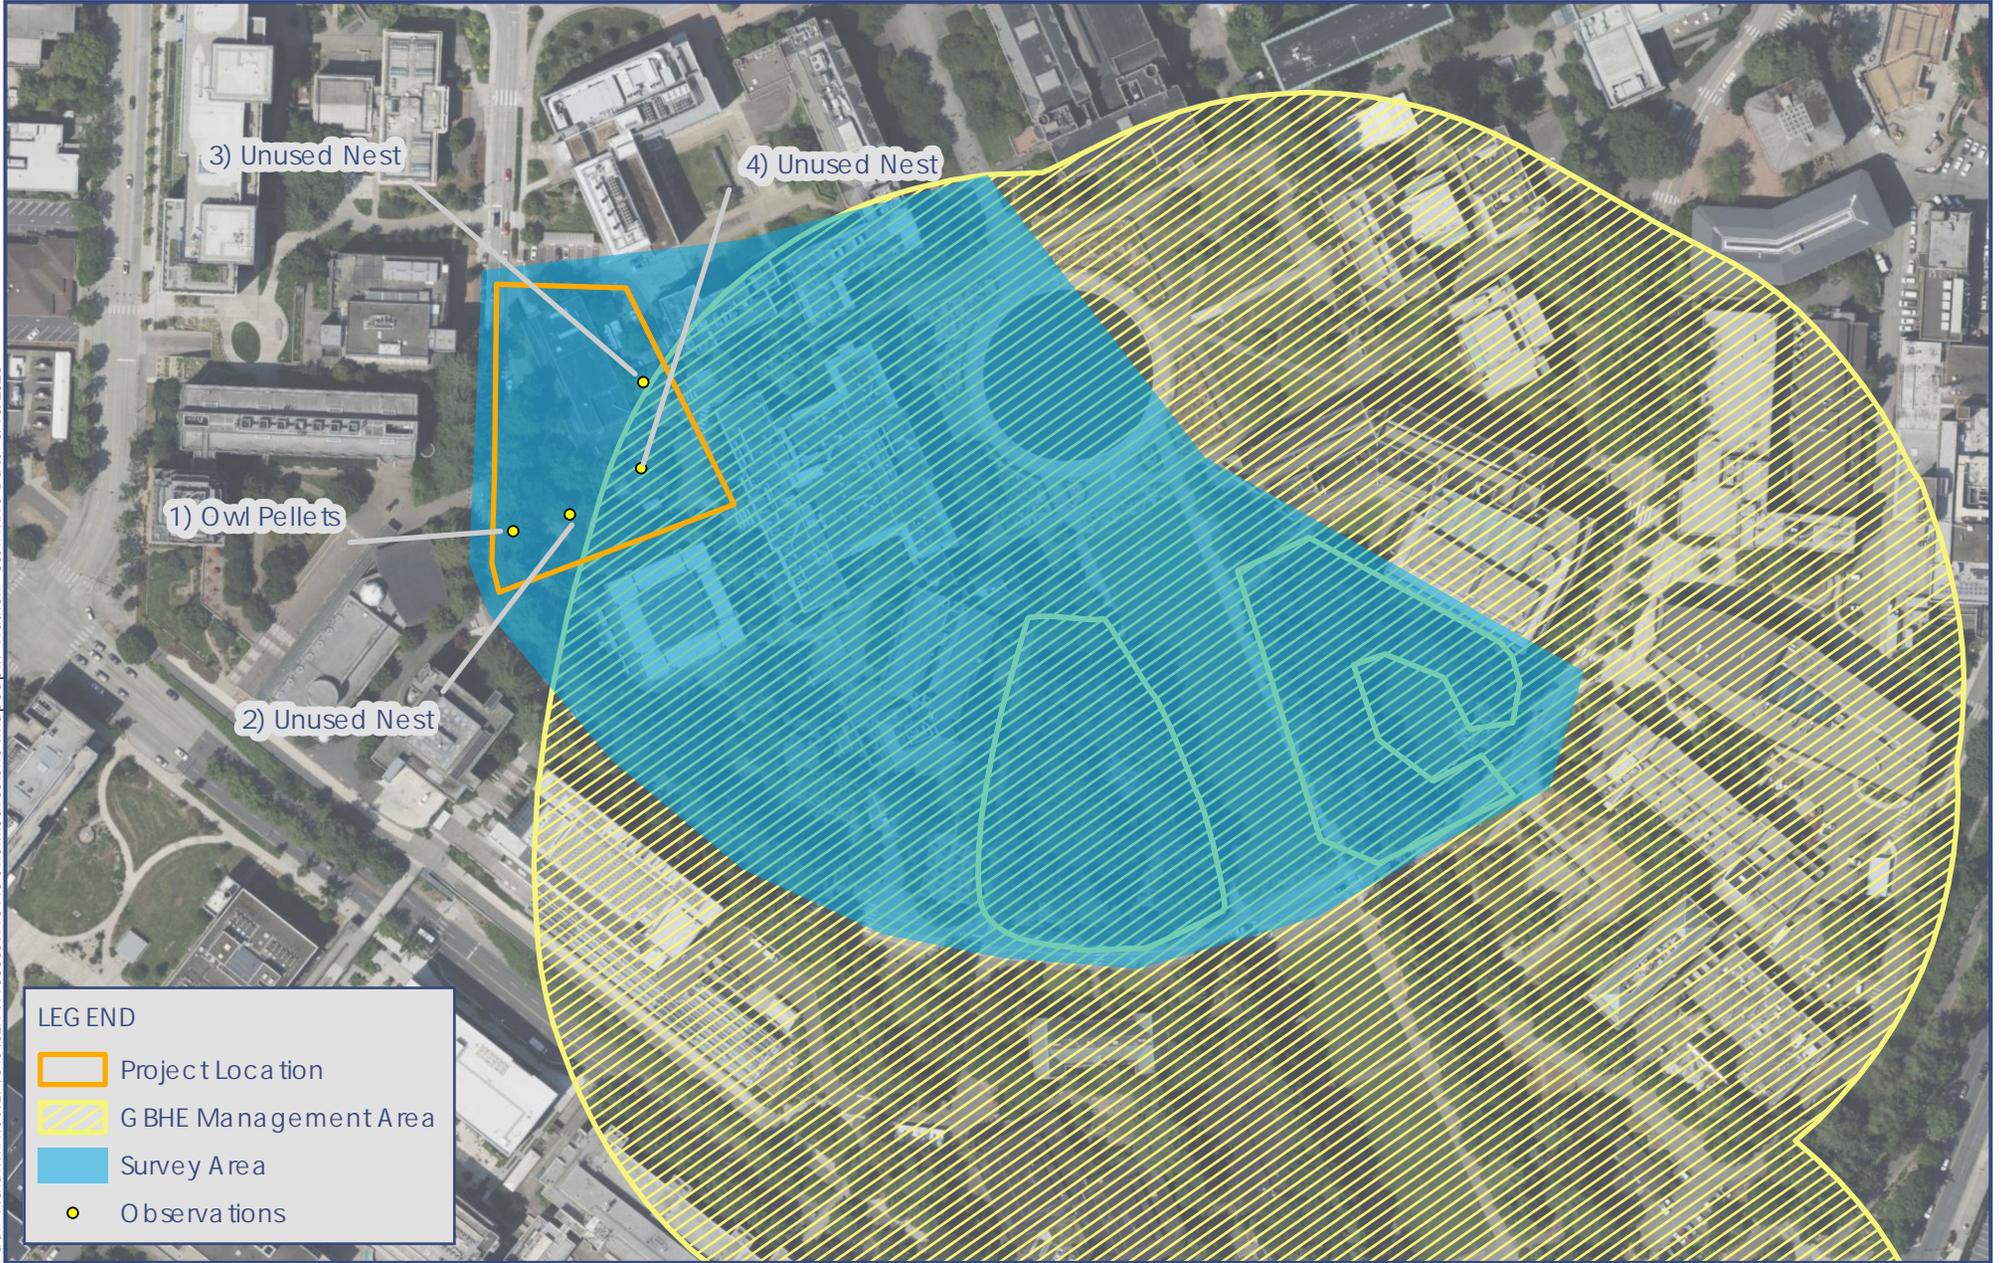
- Notes**
1. Owl Pellets Observed Under Tree.
 2. Unused Stick Nest.
 3. Potential Squirrel Nest, or Old Unused Bird Nest.
 4. Unused Stick Nest.

etc.). The locations of observed nests were collected using a handheld global positioning system unit and documented in Figure 1.
