**REQUEST FOR QUOTE:  
FRIDAY HARBOR LABS SEWER REPAIR**

## **ATTACHMENT A – SCOPE OF WORK**

### **FRIDAY HARBOR LABS SEWER REPAIR**

# **Archaeological Assessment for Sewer Maintenance University of Washington Friday Harbor Laboratories, Friday Harbor, San Juan Island, San Juan County, Washington**

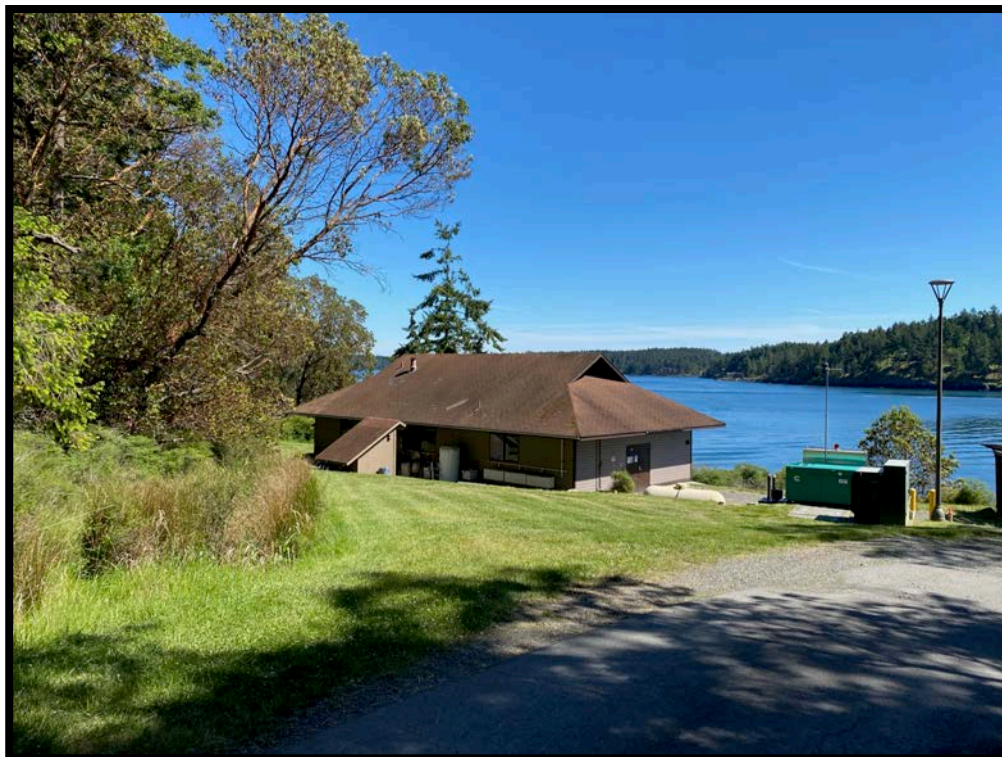
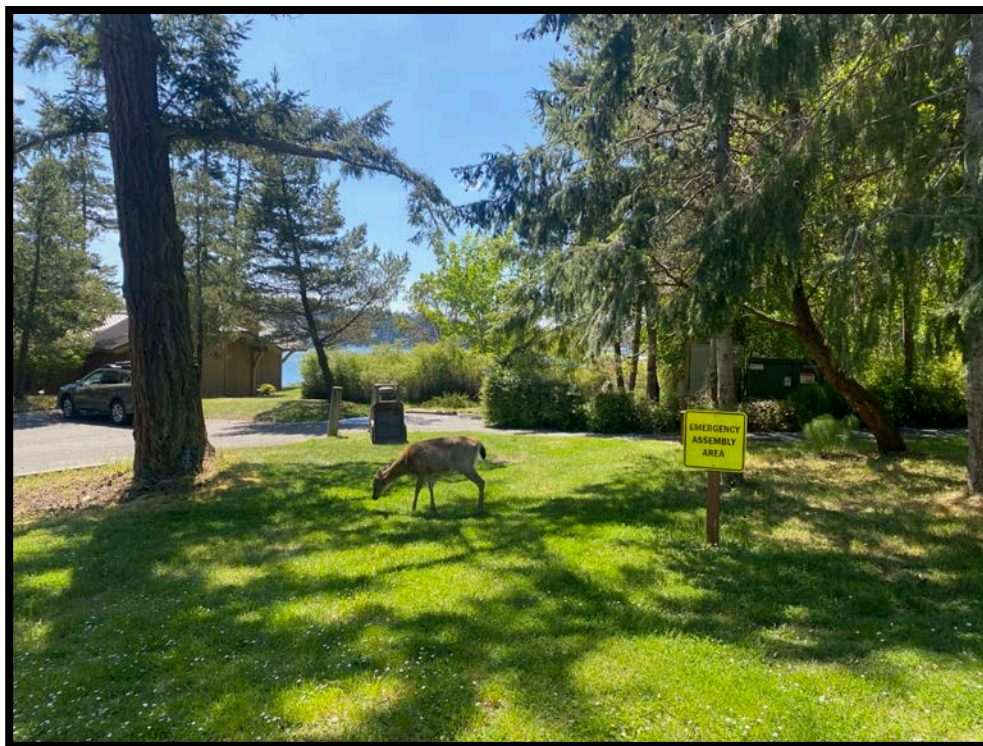
The portion of the campus that is included in the six project areas has been developed since the early 1920s to support the administration, students, faculty, and staff. The majority of the developed portion of the campus is a mixture of buildings, open manicured lawns, stands of trees, and edge habitat (Figures 13 and 14). Both gravel and asphalt roads route around the various buildings. Parking is available throughout the six project areas. The developed portion of the campus slopes down to the inlet currently known as Friday Harbor and the shoreline consists of exposed natural rock and gravel beaches.

Figure 13. An example of the current conditions. View to the southeast.

Figure 14. An example of the current conditions. View to the southwest.

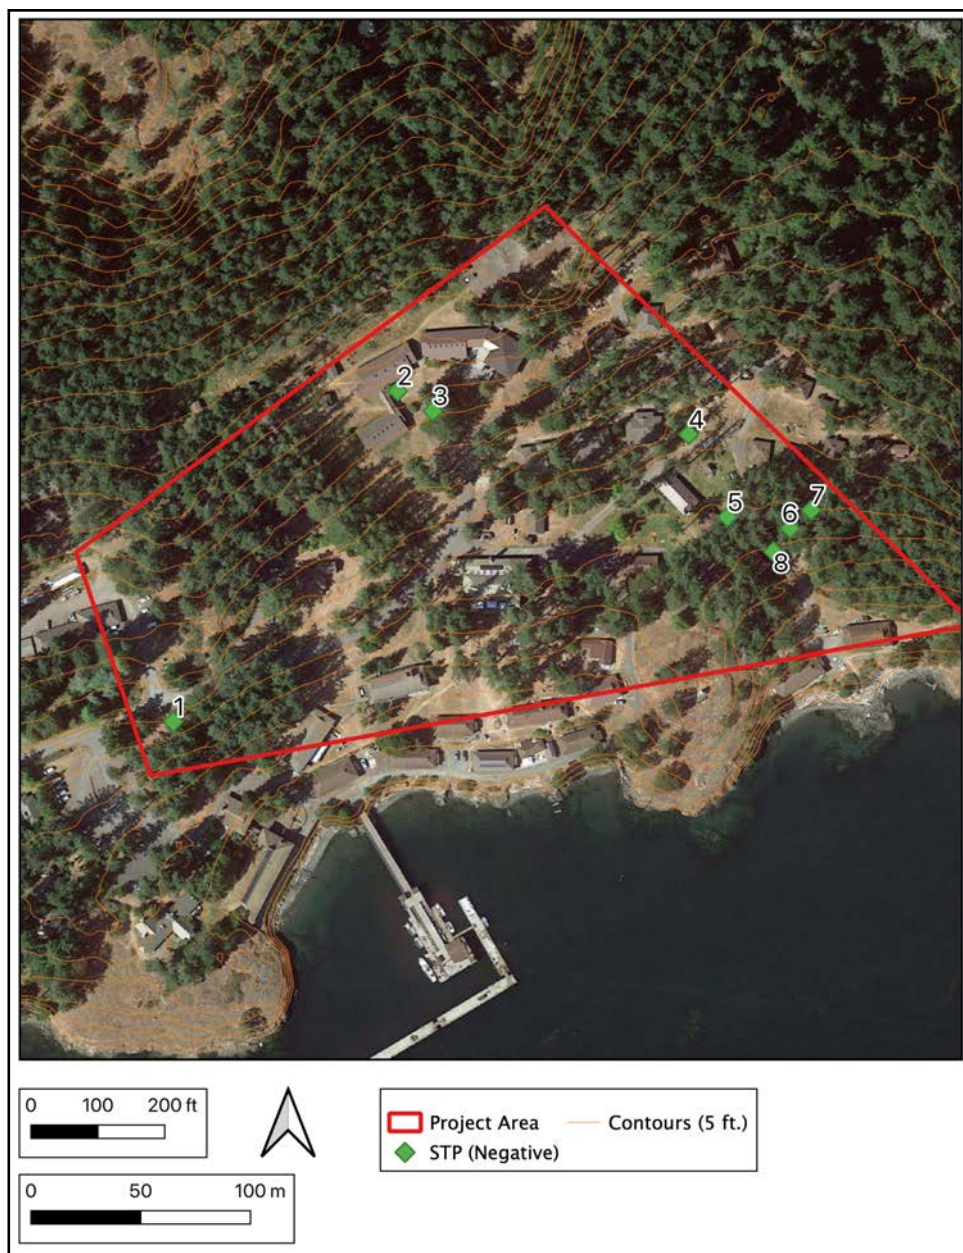
Figure 18. Survey map showing the locations of STPs.

STPs excavated in the survey area did not reveal any artifacts or evidence of archaeological features. STPs ranged in depth from 40 to 65 cm below the surface and average STP depth was 49 cm below the surface. Descriptions of STPs are available in Table 4.

In general, STP data indicates that the proposed work areas are highly disturbed from land development including the construction of the buildings, roads, and buried utilities. The only items recovered were from STP 1 in Project Area 1. A fragment of a wire nail and a single piece of clear glass was observed 20 to 30 cm and 30 to 40 cmbs (cm below surface), respectively. In Project Area 2, STP 2, the buried sewer line was uncovered at approximately 15 cmbs. The STP was abandoned and relocated 2 meters south and was negative. There were no other other objects or materials encountered in any other STP.

Sediments observed in STPs suggests that much of the area has been highly disturbed in the past most likely during the construction of the buildings, roads, and the installation of buried utilities.
