# Transition Plan

*for the*  
UW Tacoma Campus

April 2021

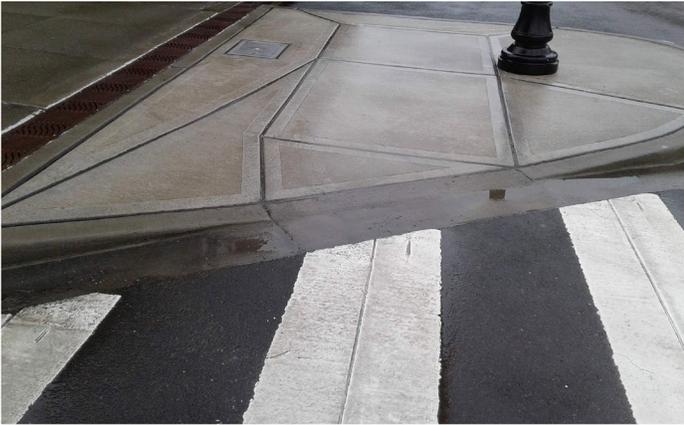
**CURB RAMPS**

- ▶ The ramp width is too narrow. One curb ramp width was less than 36 inches, three curb ramp widths were between 36 inches and 48 inches.
- ▶ The ramp running slope is too steep. Eight curb ramps were found to have a running slope greater than 8.3%.

- ▶ Ramp cross slope is too steep. One curb ramp has a cross slope greater than 2%.
- ▶ Curb ramp is missing. Seven locations were found to have no curb ramps.

For some of the high scoring curb ramps, the non-compliance is caused by the necessity to tie into the existing terrain around the curb ramp. Due to elevation changes across campus, meeting compliant grades becomes a challenge. In curb ramp design, a key goal is to limit the ramp slopes, but steep roadway grades can prevent this from being practical in many instances. Maximum extent feasible (MEF) documentation may be necessary in certain cases where it is found to be infeasible to remove all of a curb ramp's barriers. Where some barriers can still be reduced or removed, the improvement will need to be completed along with the MEF documentation. At locations where curb ramps are missing, different solutions could be applied such as installing a new curb ramp, adding signage to prevent crossings, or raising the crossing to the elevation of the curb.

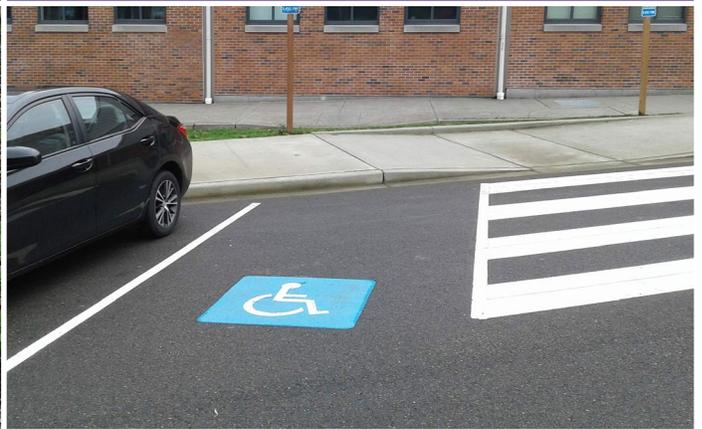
**ACCESSIBLE PARKING**

Parking stalls designated as accessible stalls on-street, in surface lots, and parking garages were inventoried, totaling 26 parking stalls. Dimensions, slopes, signage, and vertical clearances were surveyed for accessible parking stalls and associated access aisles. The following characteristics were found for the accessible parking stalls on campus.

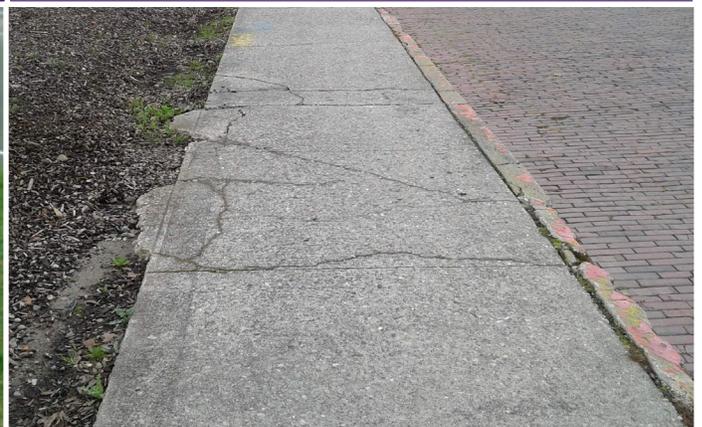
**SIDEWALKS**

Several miles of sidewalks and pathways on campus are non-compliant with varying levels of access along the segments. Common attributes for sidewalks and driveways are shown in Figure 2-4. Sidewalk segments that earned an accessibility score of 16-30 were categorized as non-compliant. Sidewalks that received an accessibility score of 1-15 were considered minor non-compliant. See Section 5.2.1 for details on accessibility scores. The most common hazards along the pathways were gaps between concrete panels, uplifted sidewalks panels, and utility boxes without non-slip coatings. Gaps between panels often come from concrete shrinkage and wear on gap sealant.

- ▶ The cross slope of the sidewalk is too steep. Around 60% of sidewalk segments were found to have at least one location where the cross slope was greater than 2%.
- ▶ The running slope of the sidewalk is too steep. Around 30% of sidewalk segments have a non-compliant running slope in at least one location along the segment. Where sidewalks were adjacent to roadways the running slope was compared to the roadway grade when the sidewalk running slope was greater than 5%. If the running slope and roadway grade matched, then the running slope was considered compliant.
- ▶ The sidewalk has fixed/non-fixed barriers and other discontinuities that impede required usable pedestrian space. Vertical and horizontal discontinuities were regularly found across campus. Other less common obstacles such as untrimmed trees and bushes and parked cars were also found.

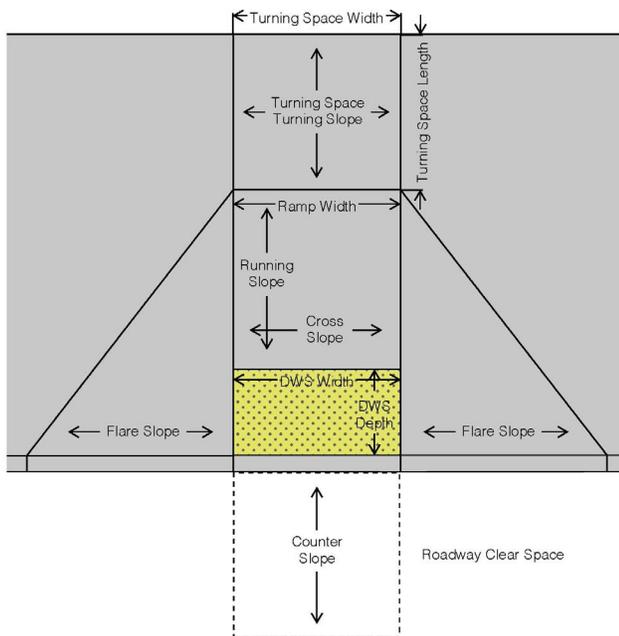
Figure 2-2 Perpendicular Curb Ramp Attributes

Figures 2-2 and 2-3 show the major components of a typical perpendicular and parallel curb ramp, respectively. Ninety percent of the curb ramp locations identified are either non-compliant or missing. The data surveyed for verifying curb ramp compliance was divided into two overarching categories: non-compliant and minor non-compliant. The findings demonstrated that most of the curb ramps on campus fall into the non-compliant category. Non-compliant curb ramps are existing/missing curb ramps given an accessibility score of 30. Minor non-compliant curb ramps received an accessibility score of 1-29. For further detailing on scoring, see Section 5.2.1.

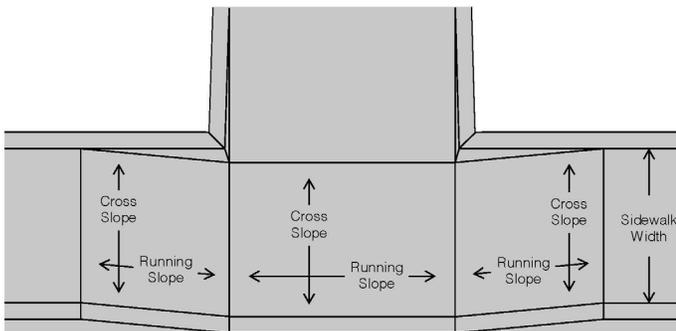
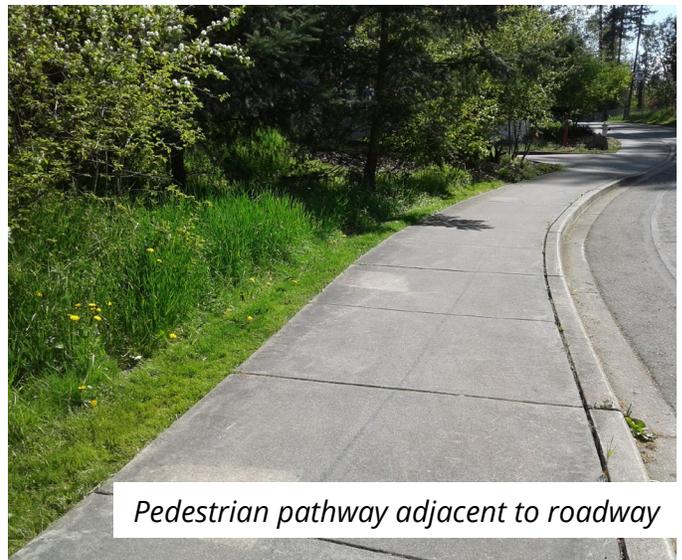
Figure 2-4 Driveway and Sidewalk Attributes

Pedestrian pathway adjacent to roadway

- ▶ Non-compliant driveways intersect the sidewalk. Five driveways were identified as non-compliant. All of these driveways have issues related to the cross slopes exceeding the acceptable 2% threshold.

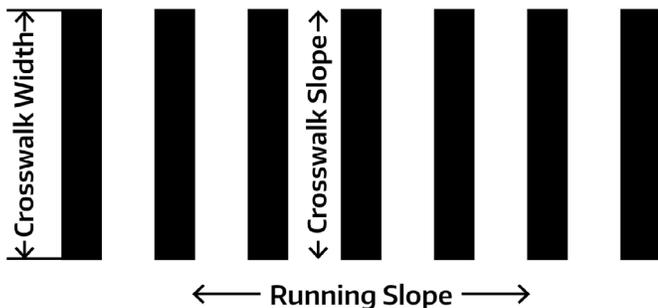
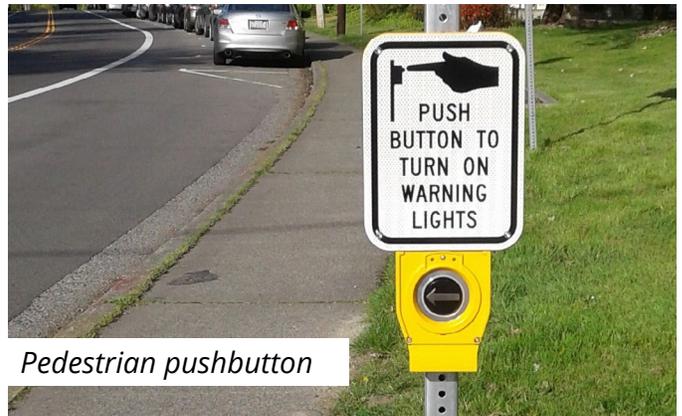
Figure 2-5 Crosswalk Attributes

Pedestrian pushbutton

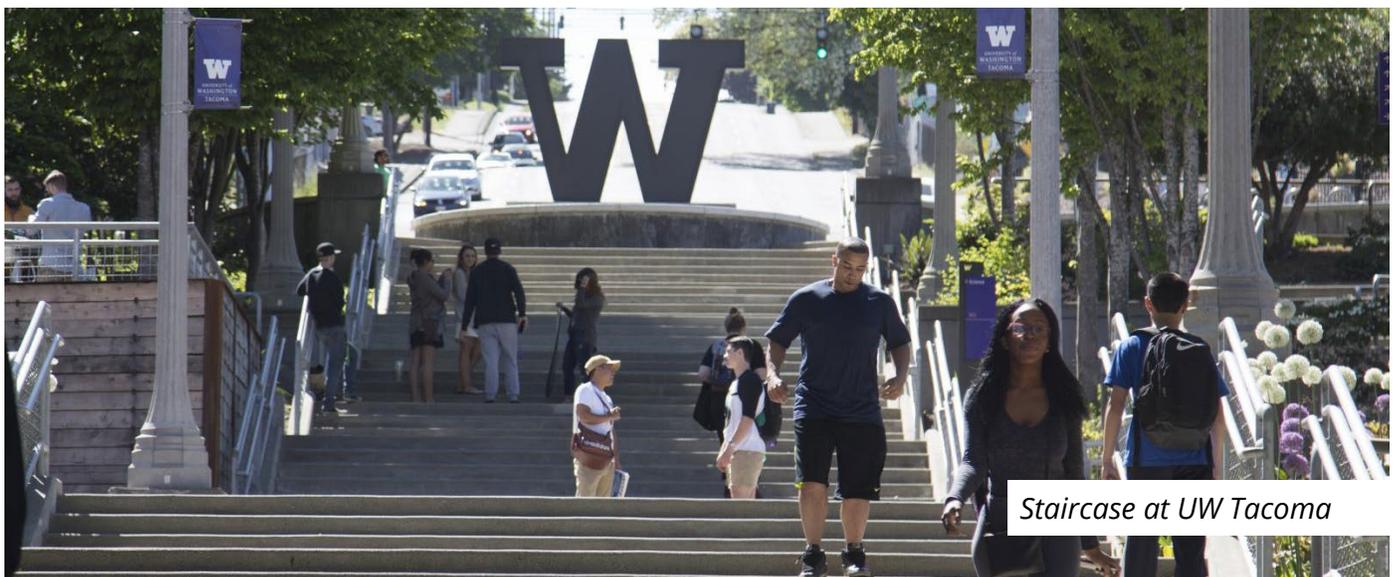
*Staircase at UW Tacoma*
